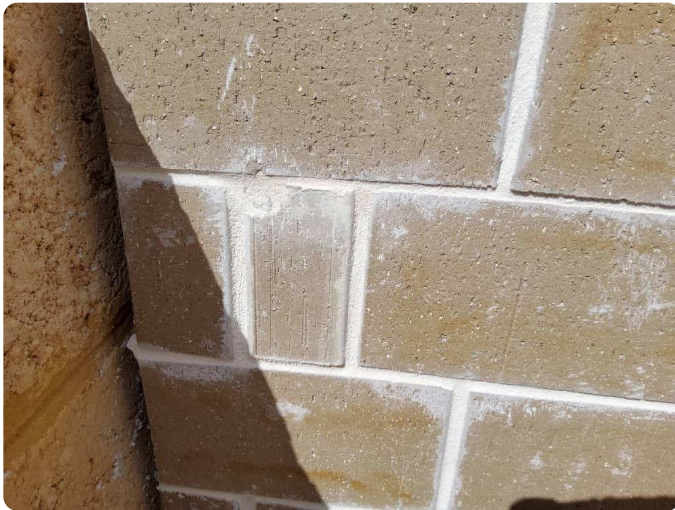
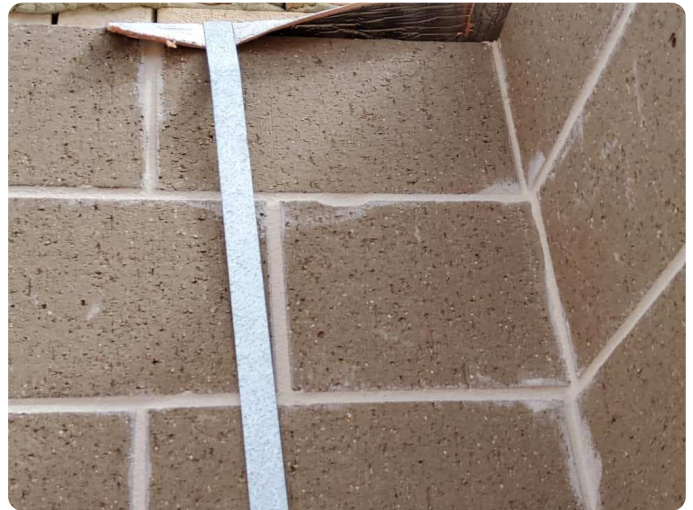
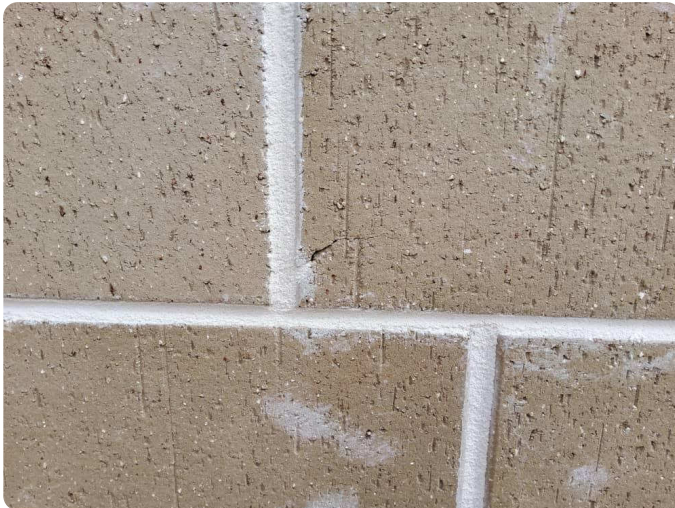
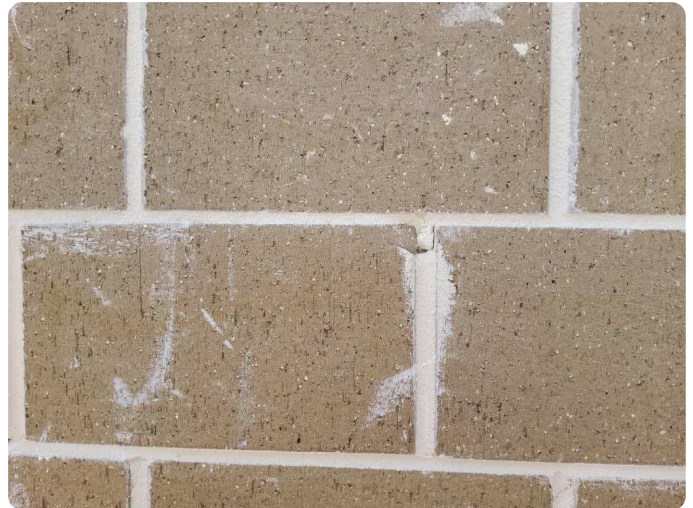
1.1 Damaged bricks

As per the images there are damaged brick (s) which require installation or replacement.

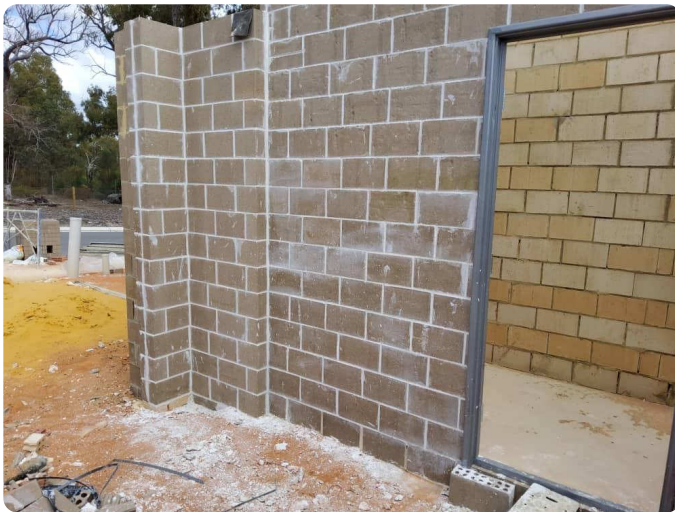
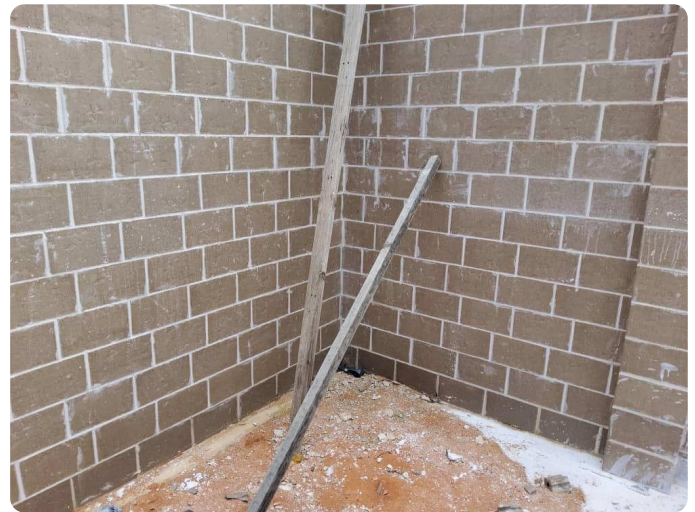
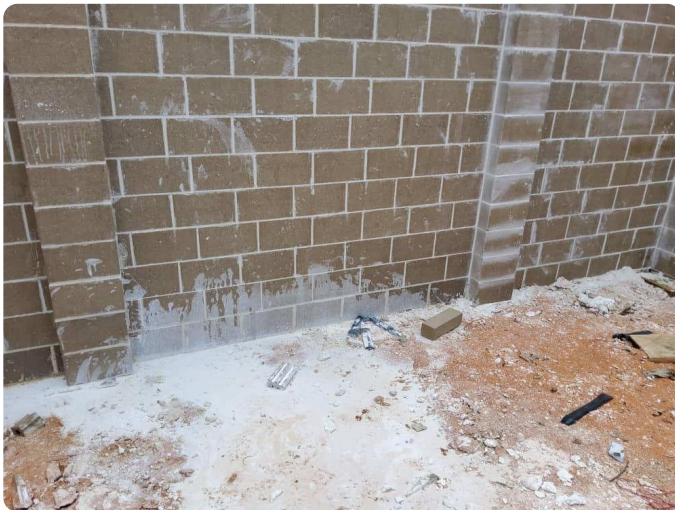
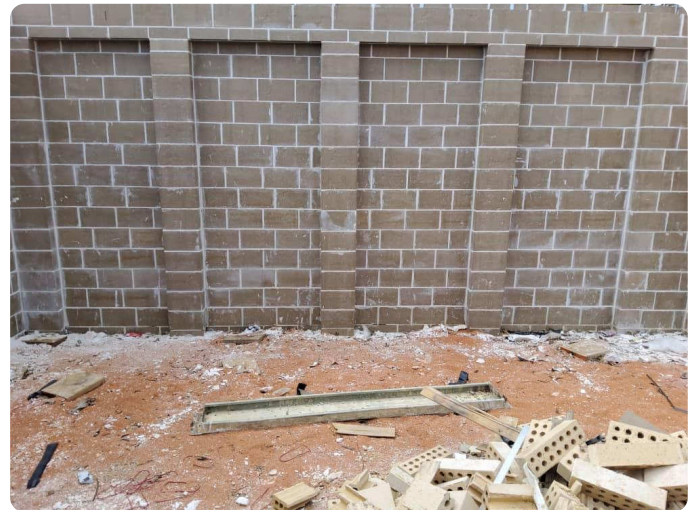
1.2 Bricks not clean

As per the images, the brickwork is very dirty and requires cleaning. Additional photos have been provided to summarise the extent of this issue.

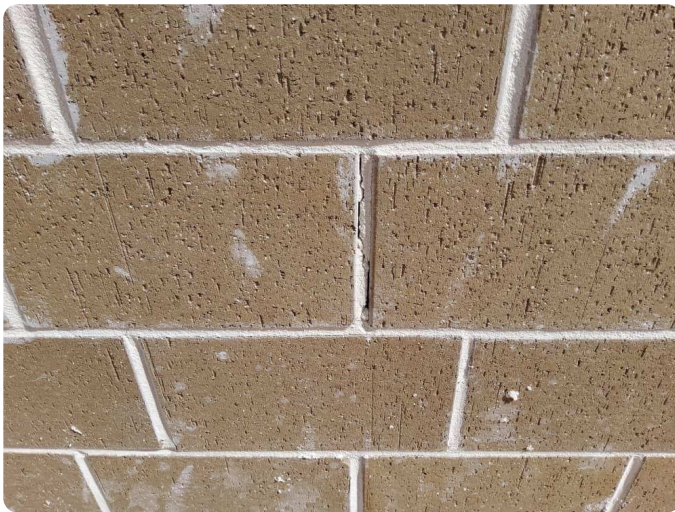
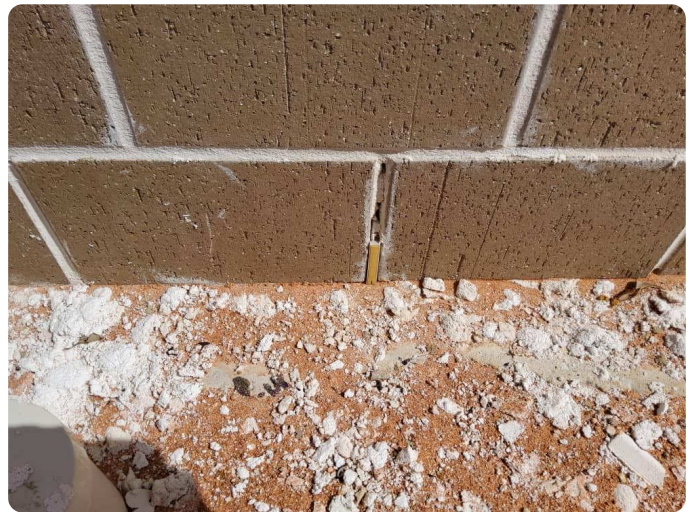
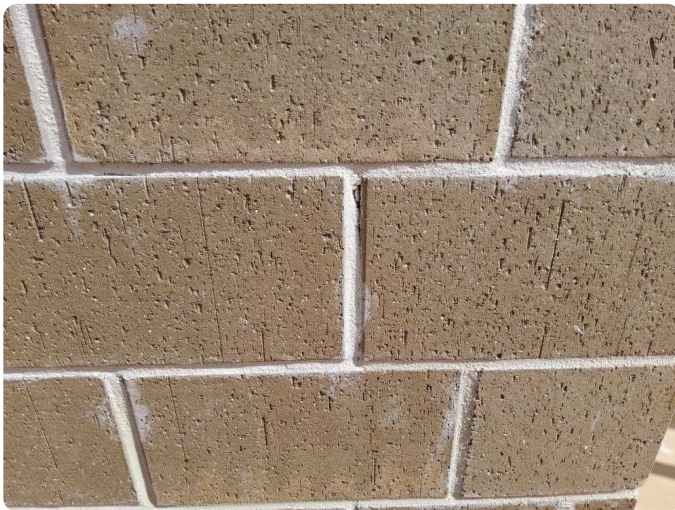
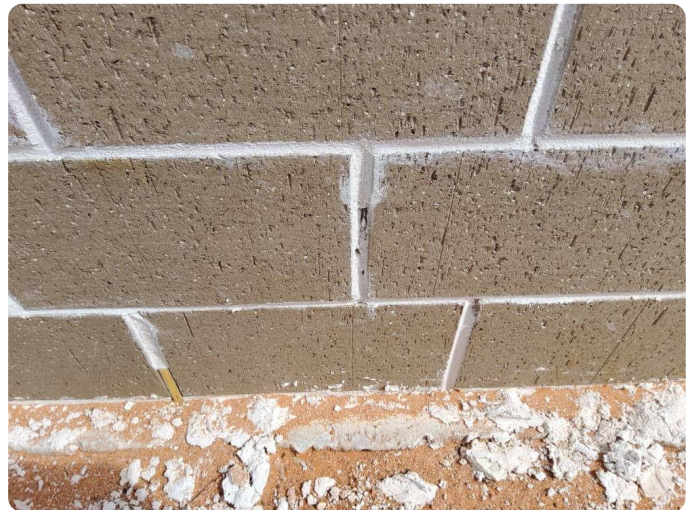
2.1 Mortar holes and voids

The masonry work wall shown in the image is defective as there are holes or voids in the mortar beds or perpend and they are visible from a normal viewing position. Builder to remediate.

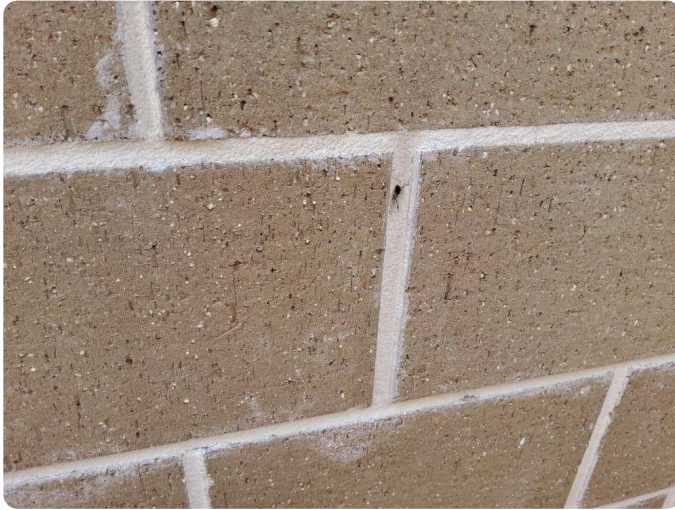
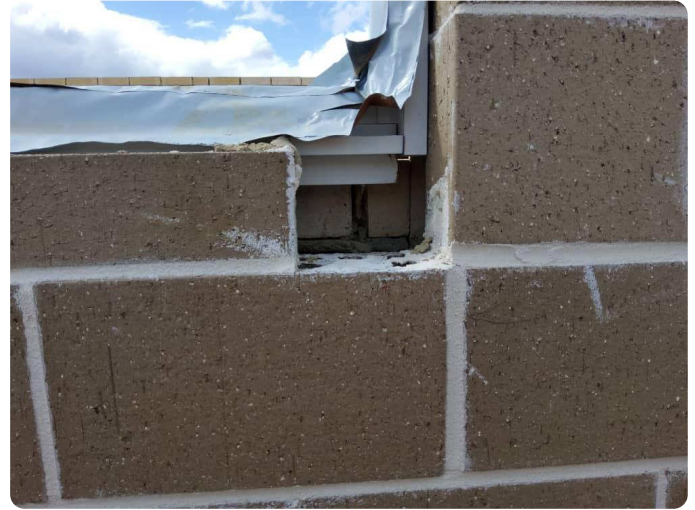
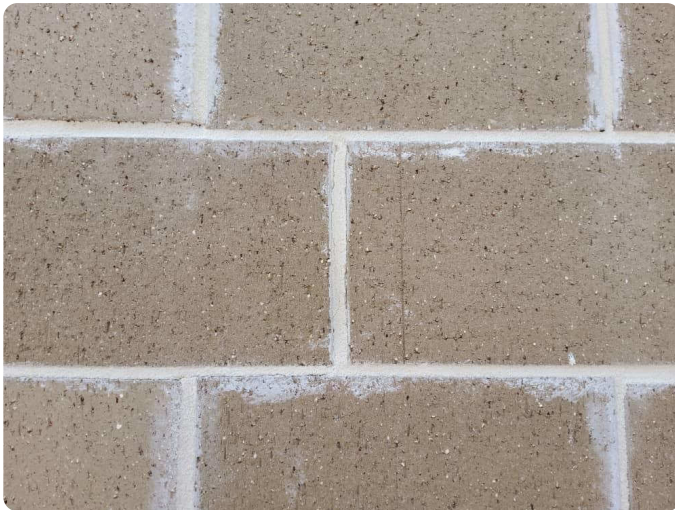
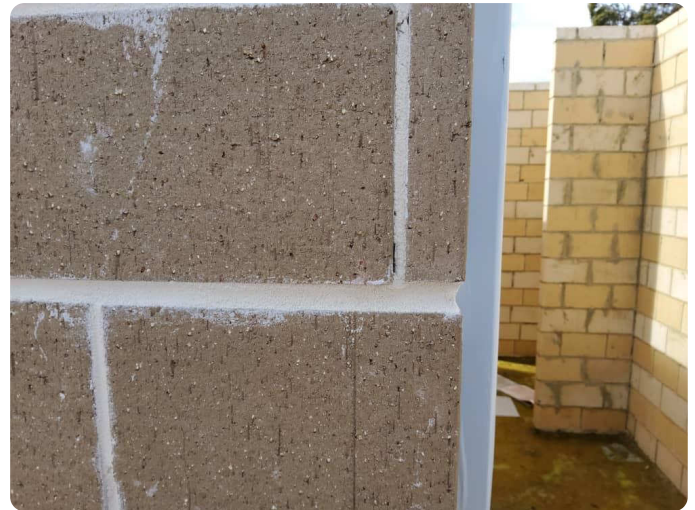
2.2 Mortar holes and voids

The masonry work wall shown in the image is defective as there are holes or voids in the mortar beds or perpend and they are visible from a normal viewing position. Builder to remediate. Multiple instances of this issue were identified on the property. Additional photos have been provided to summarise the extent of this issue.

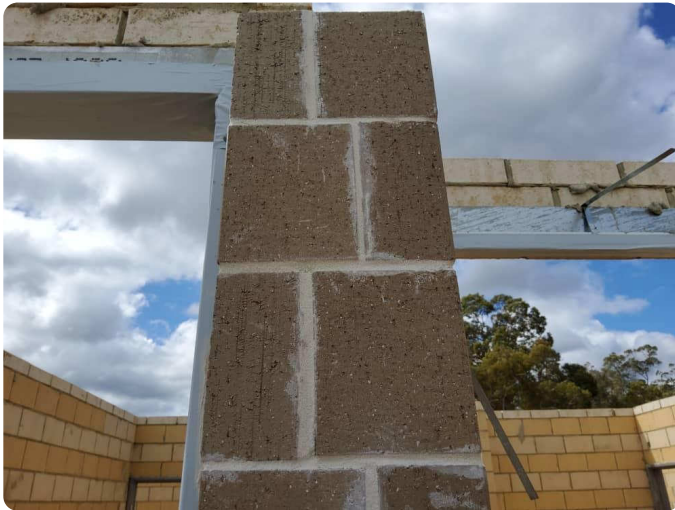
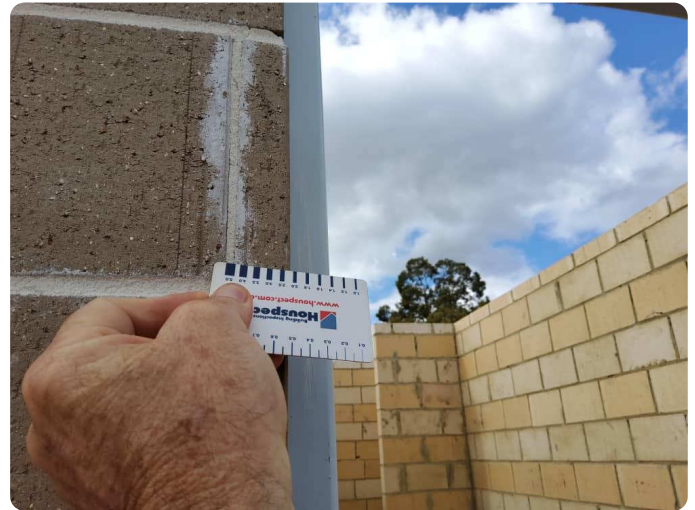
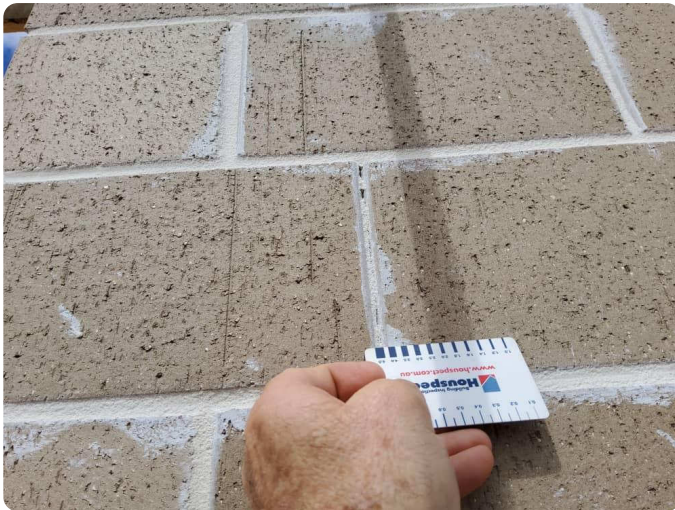
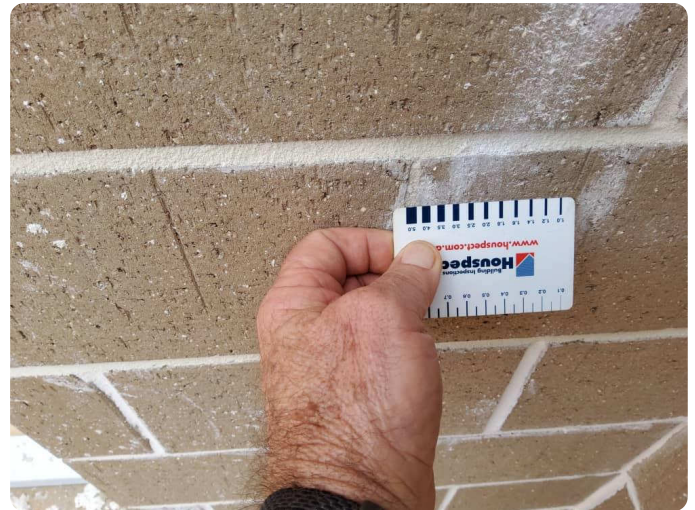
2.3 Mortar perpend is too narrow

The perpend joint on the masonry wall shown in the image is outside acceptable tolerances. Perpend joints are not permitted to be less than 5mm minimum or documented thickness - 3mm Multiple instances of this issue were identified on the property. Additional photos have been provided to summarise the extent of this issue.

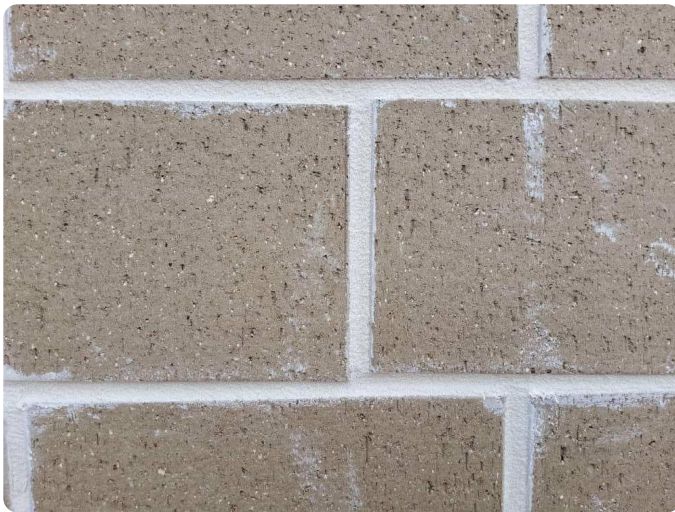
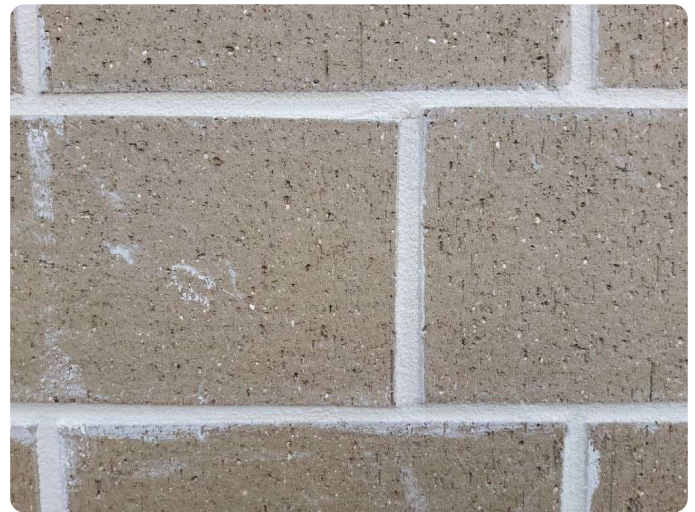
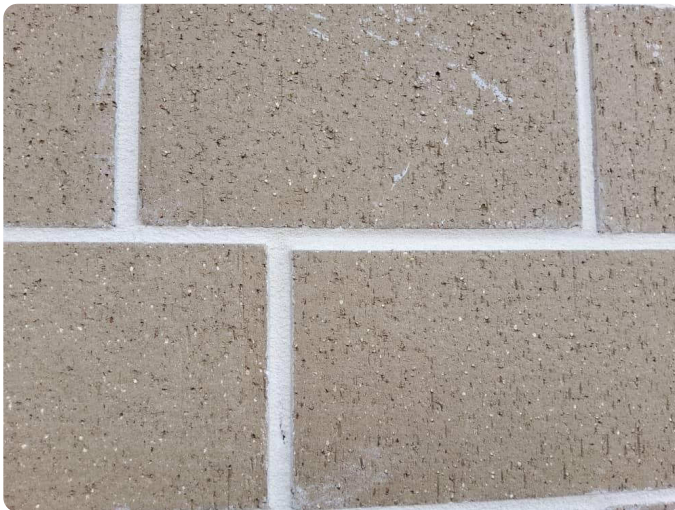
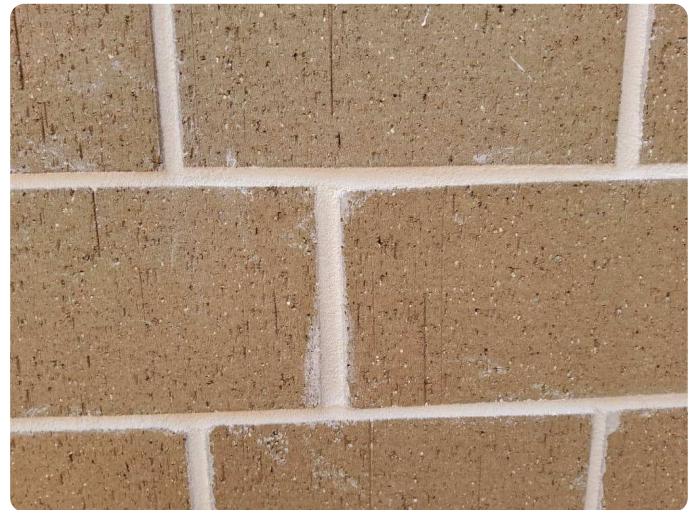
2.4 Finish poor

The overall finish of the completed brickwork is of a poor quality. Builder to comment and remediate as required. Additional photos have been provided to summarise the extent of this issue.

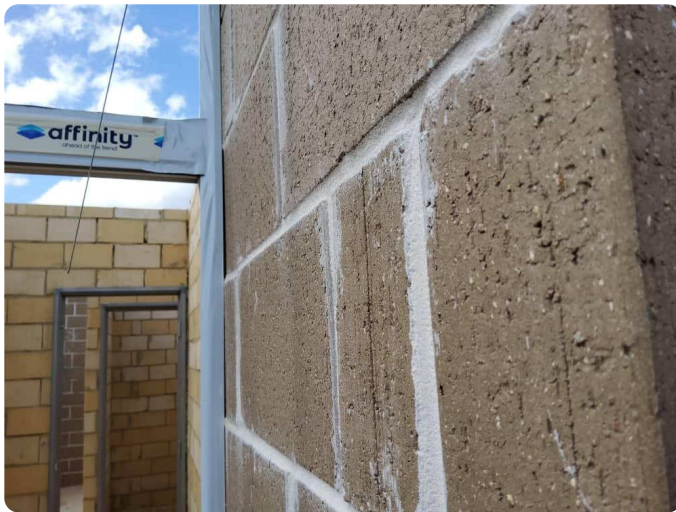
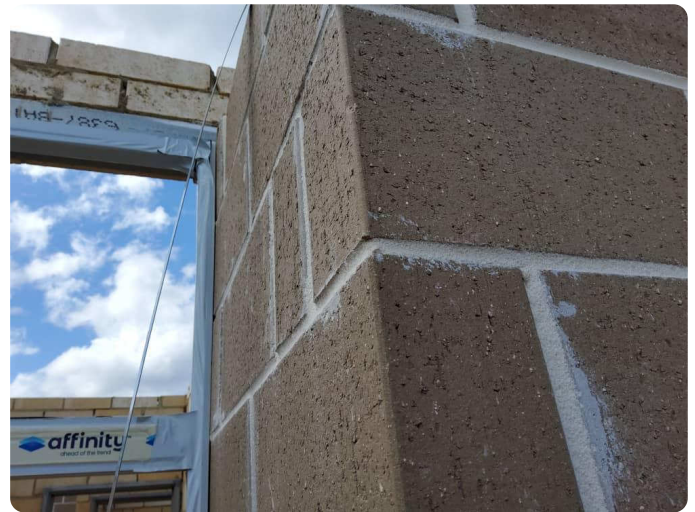
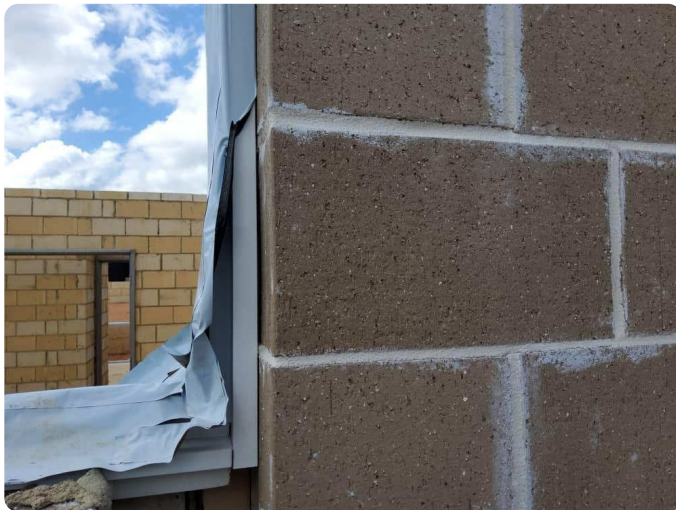
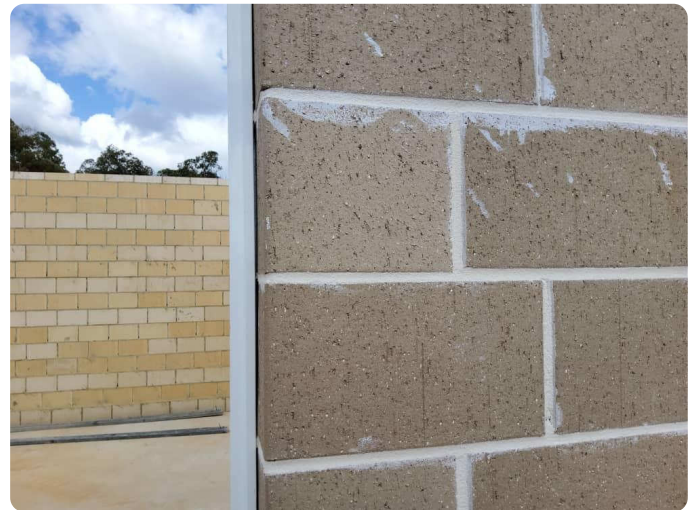
2.5 Gaps at window frames

There are excessive gaps between the window frames and the brickwork. Builder to comment. Additional photos have been provided to summarise the extent of this issue.

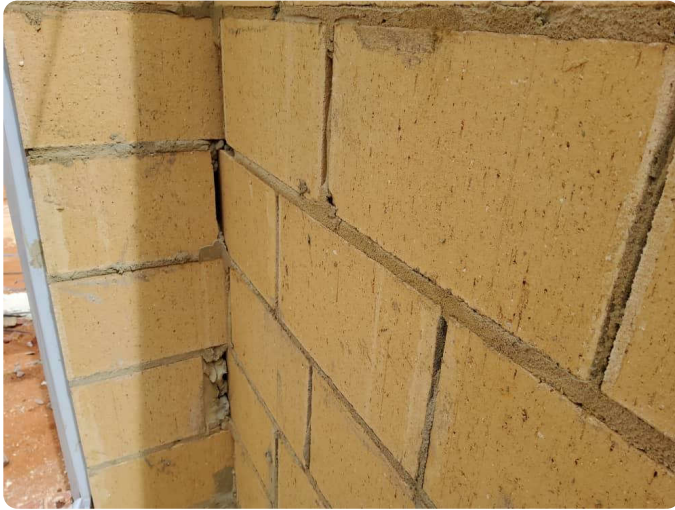
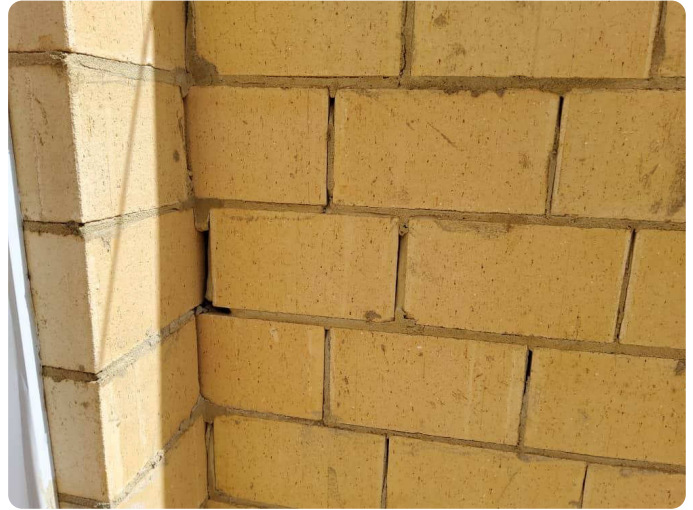
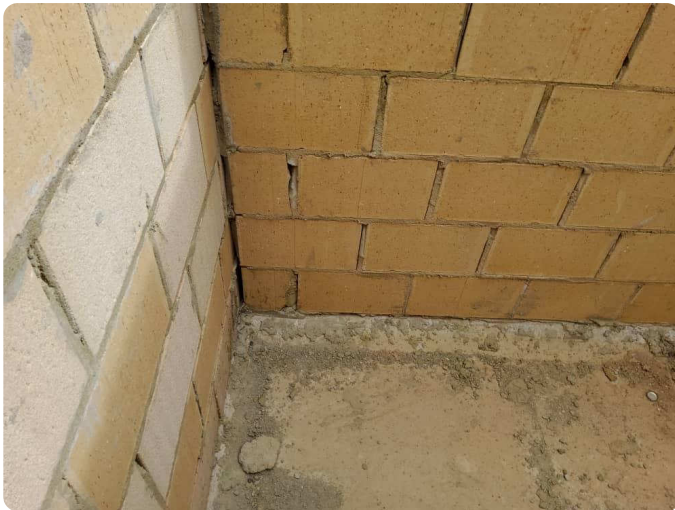
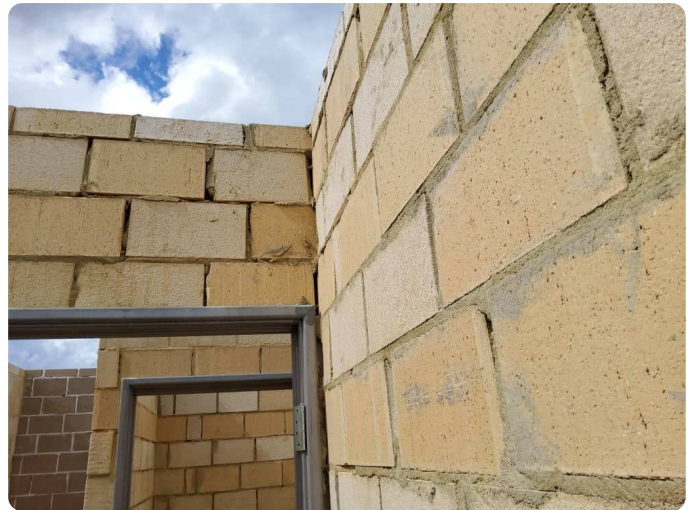
2.6 Mortar holes and voids

The masonry work wall shown in the image is defective as there are holes or voids in the mortar beds or perpend and they are visible from a normal viewing position. There are also large voids and unfilled joints to the walls that will be rendered. Builder to remediate. Additional photos have been provided to summarise the extent of this issue.

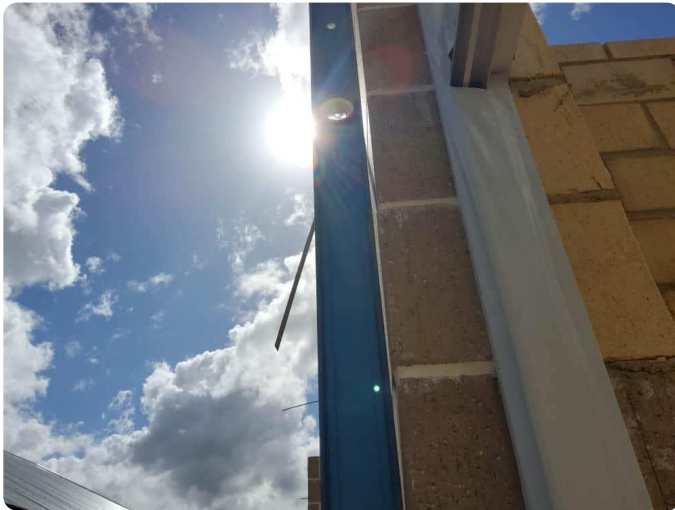
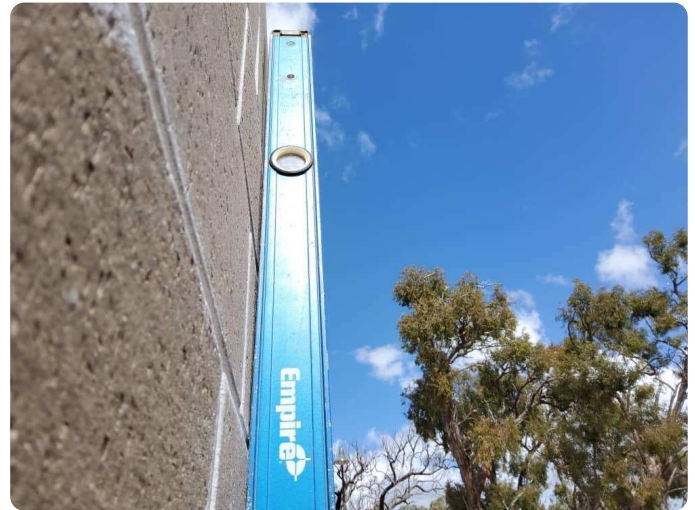
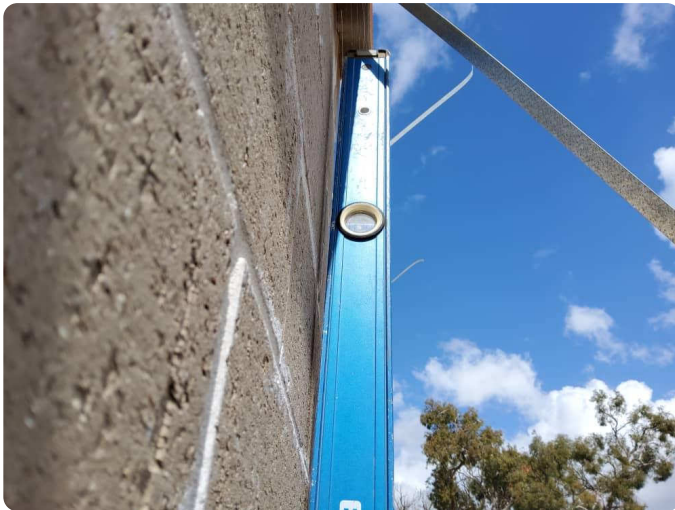
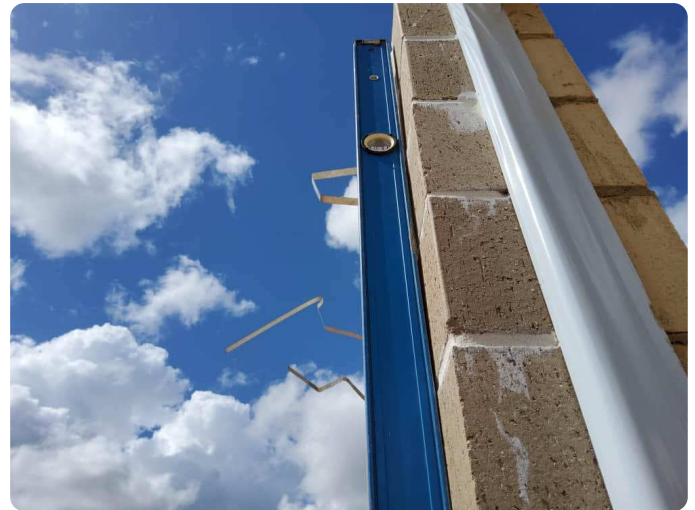
2.7 Walls bowing

The brickwork is defective as shown in the images provided as the brickwork bows by more than the maximum horizontal or vertical deviation of a surface from a plane surface (bow) in any 2m length (refer Appendix F in AS 3700:2018) by more than 5 mm. Multiple instances of this issue were identified on the property. Additional photos have been provided to summarise the extent of this issue.

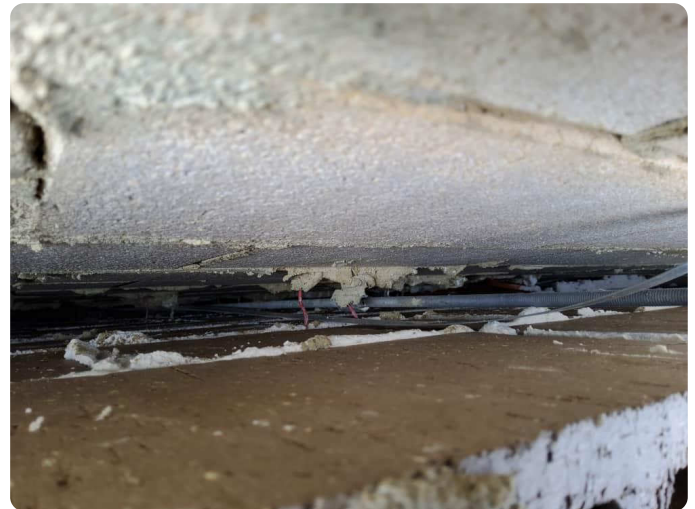
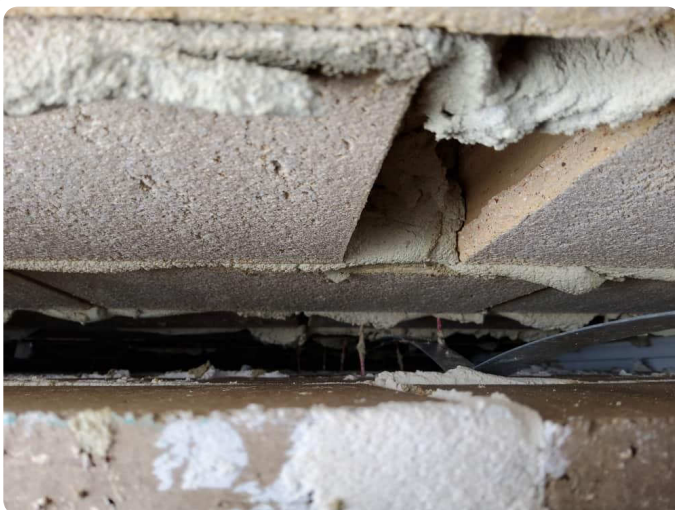
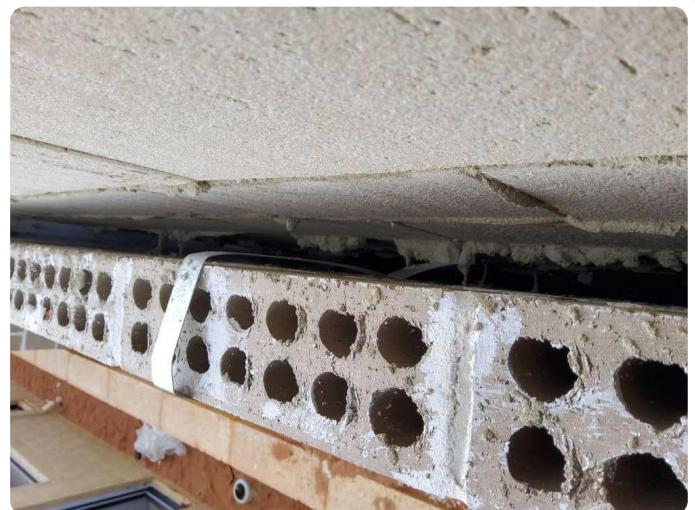
2.8 Wire ties issues

The masonry wall ties in the masonry wall shown in the image is inconsistent with the requirements of the BCA 6.1.8.1. AS 4773.2- 2015 requires that wall ties shall be placed in such a manner that they are within? (a) 300 mm of control joints; (b) 300 mm from the ends and tops of walls; (c) 300 mm from openings and intersecting walls; (d) 300 mm above intermediate floor level in two storey construction; and (e) 400 mm below intermediate floor level in two storey construction except where circumstances do not allow for this, such as where the frame is obscured by window flashing. In all cases, the maximum vertical and horizontal spacing shall not exceed 600 mm. Ties shall be doubled at intersecting walls, as shown in Figure 10.11(A). Ties shall be embedded at least 50 mm into each masonry leaf.

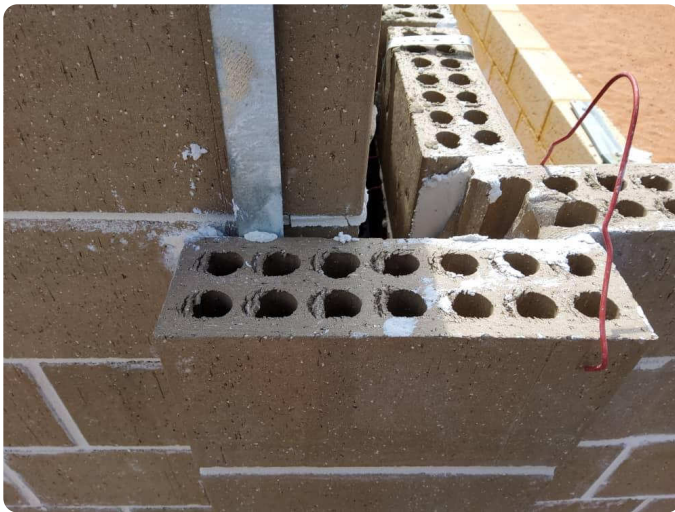
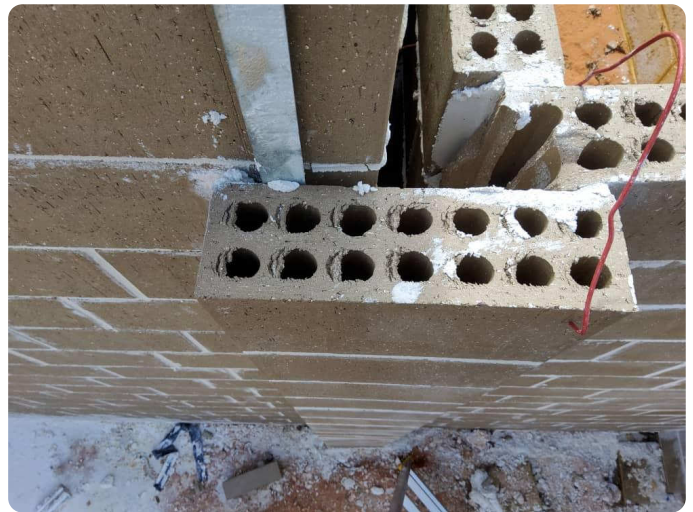
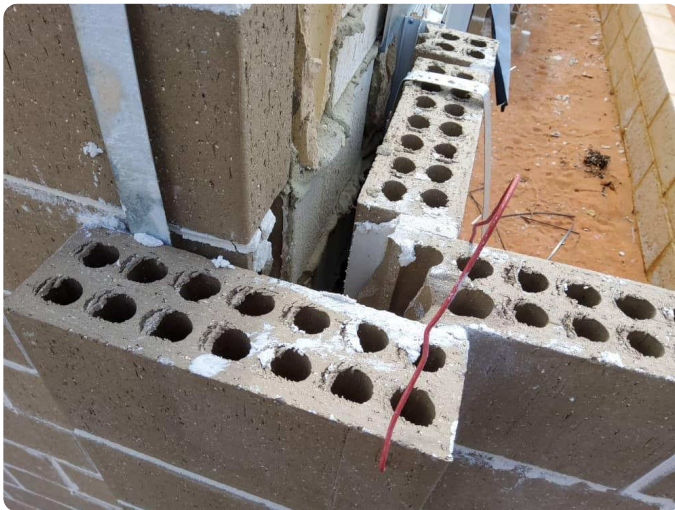
3.1 Cavity closure defective

The cavity closer shown in the images is not flashed and the cavity is breached. Remediation by the Builder is required.

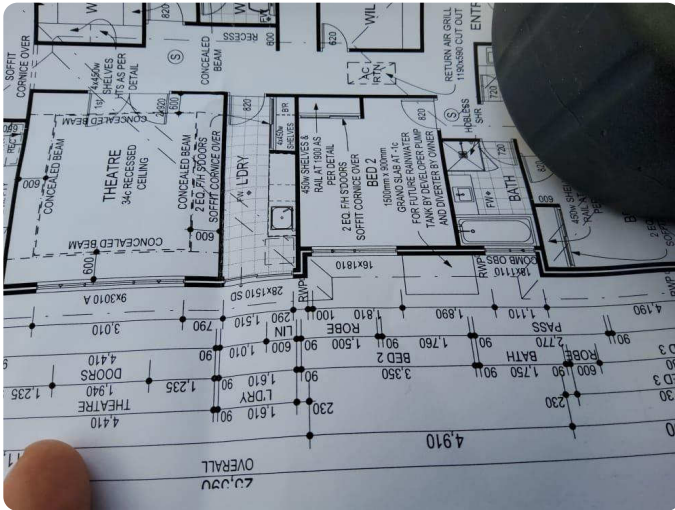
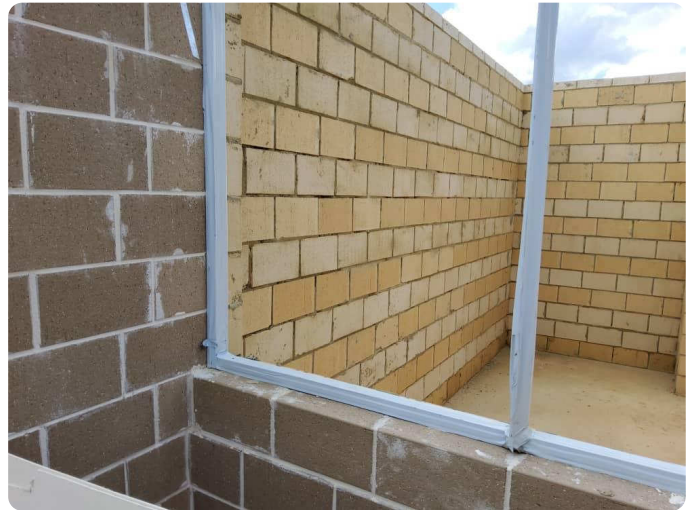
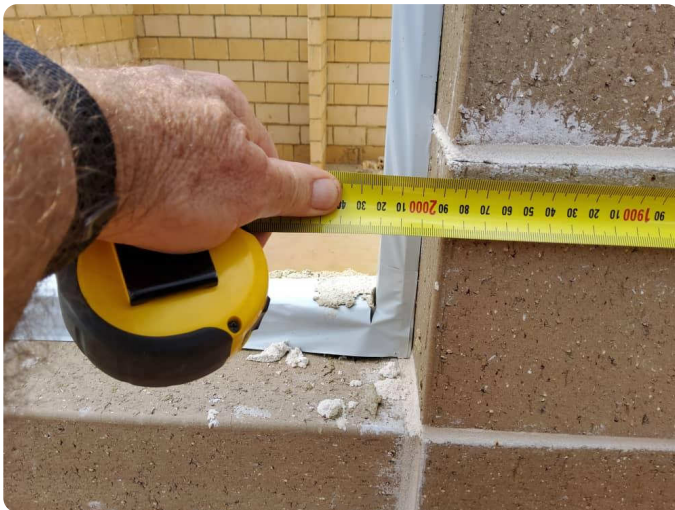
4.1 Window location inconsistent with plans

The window to bedroom 2 is not correctly located as per the plans provided. Builder to rectify.

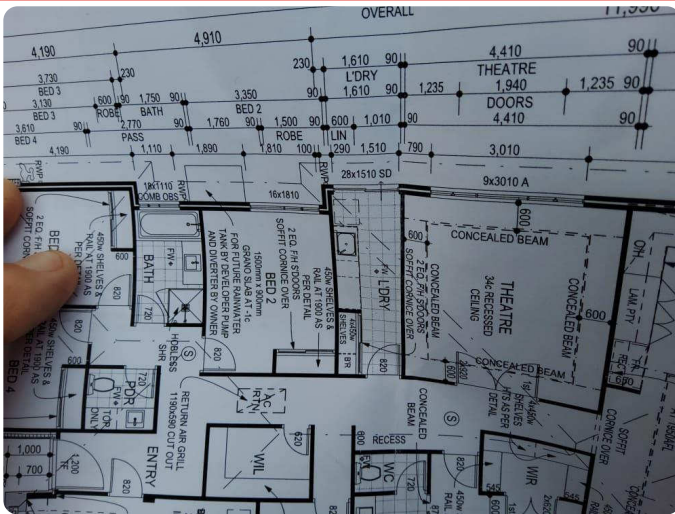
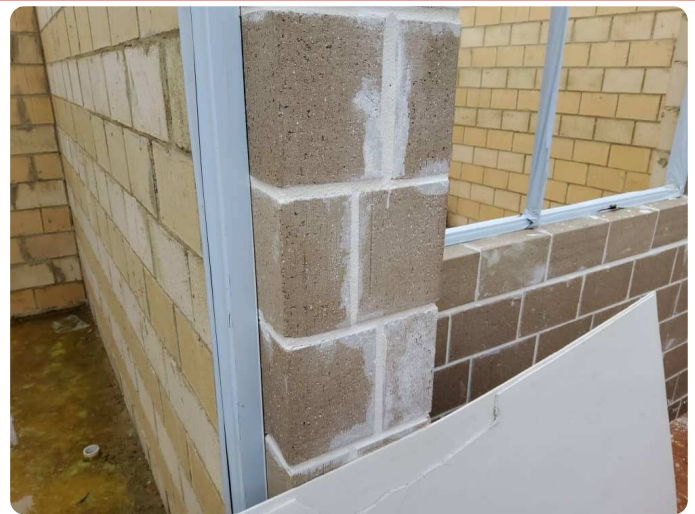
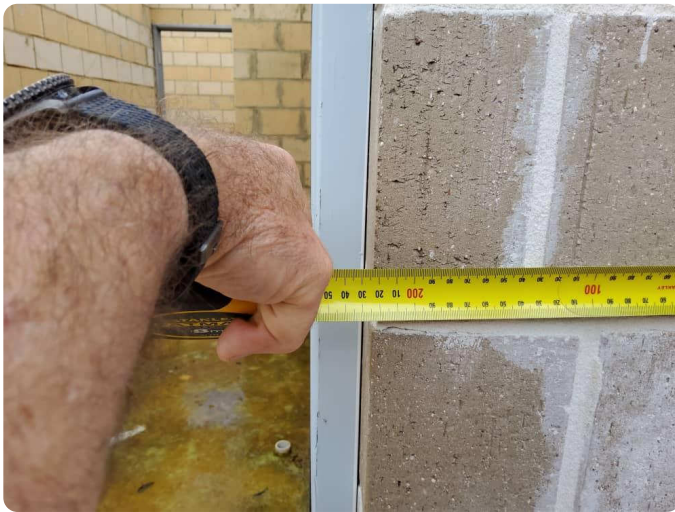
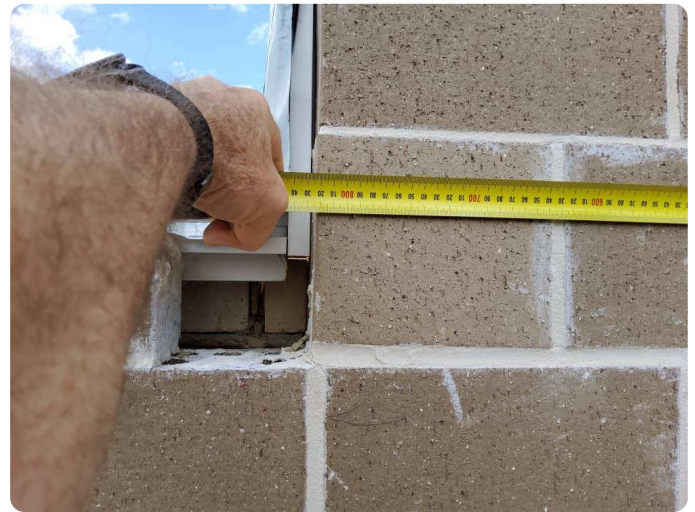
4.2 Laundry door location inconsistent with plans

The laundry door has not been located as indicated on the plans provided. This has resulted in a small cut brick to the left-hand side. Builder to rectify.

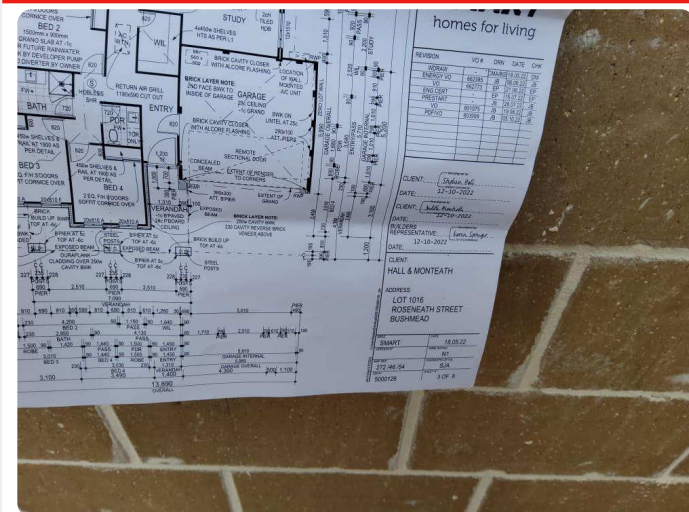
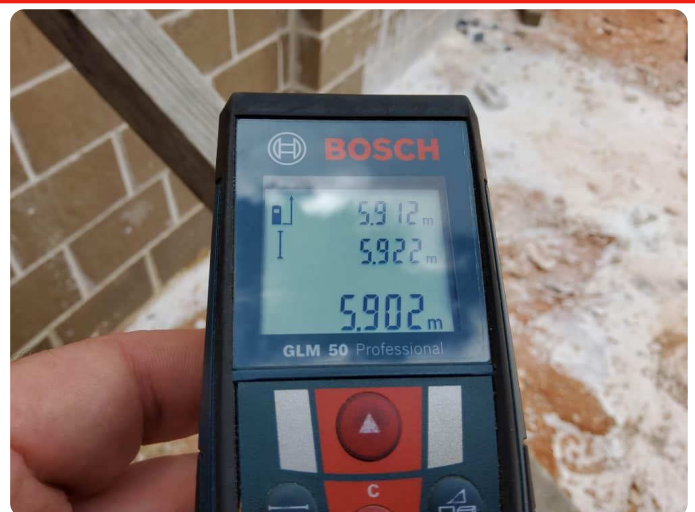
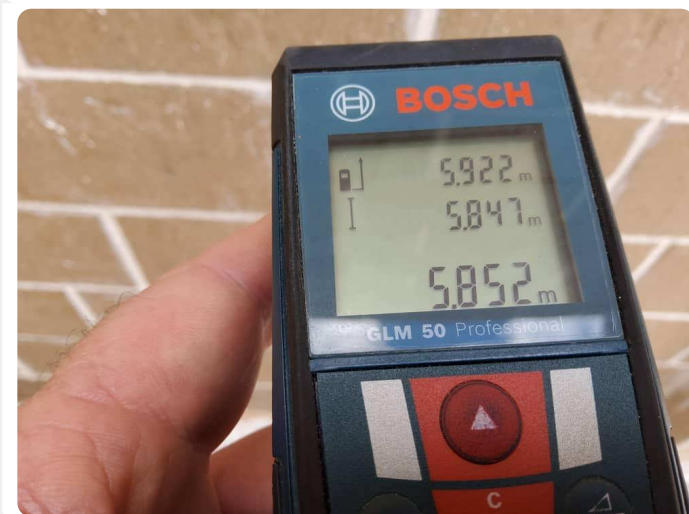
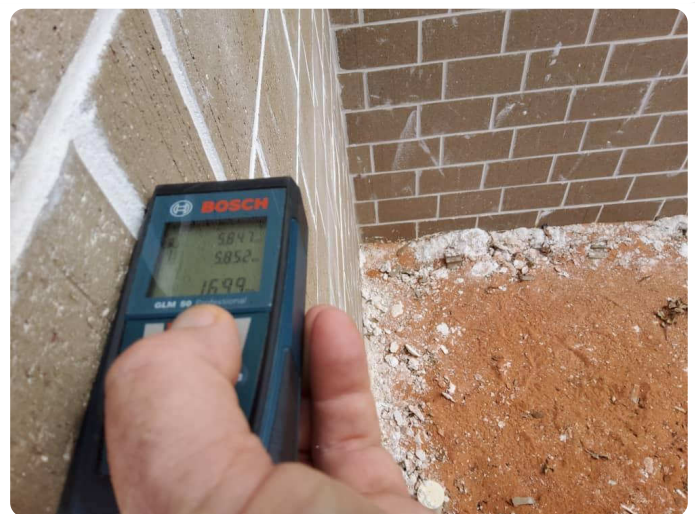
4.3 Room dimensions inconsistent with plans provided

The room dimensions as per the images provided are inconsistent with the approved construction plans provided. The rear of the garage is 100mm wider than is indicated on the plans. The front width is correct. The north-east corner of the garage may be encroaching on the adjoining property as the set back at this location was only 100mm. Builder is required to rectify and comment as required.

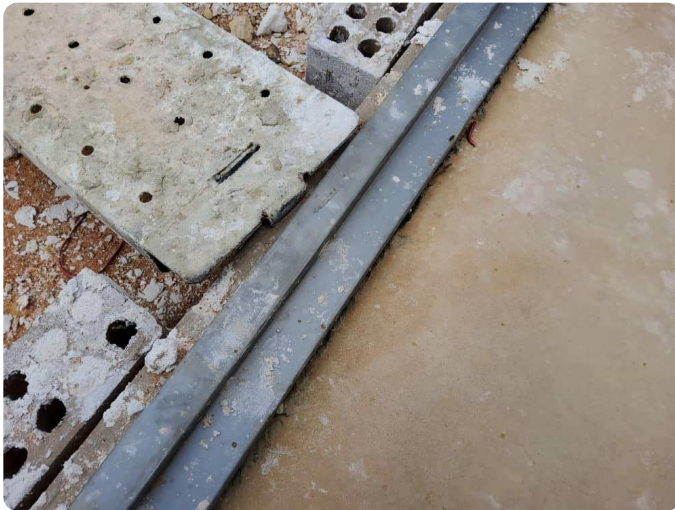
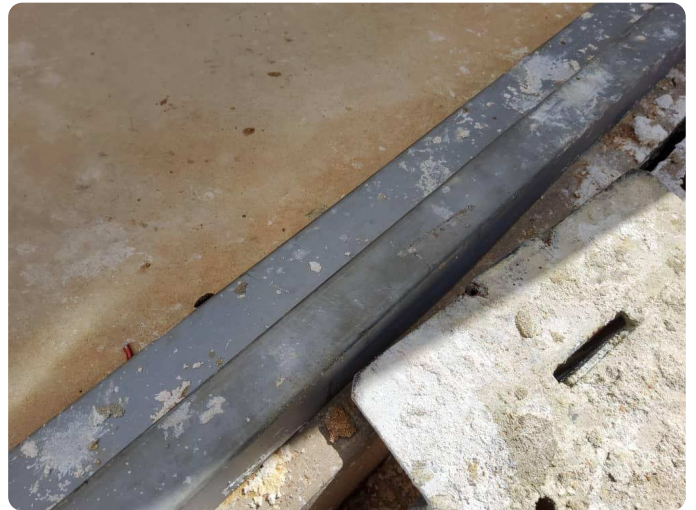
7.1 Door frame damaged

The sill of the door frame in the images has impact damage.

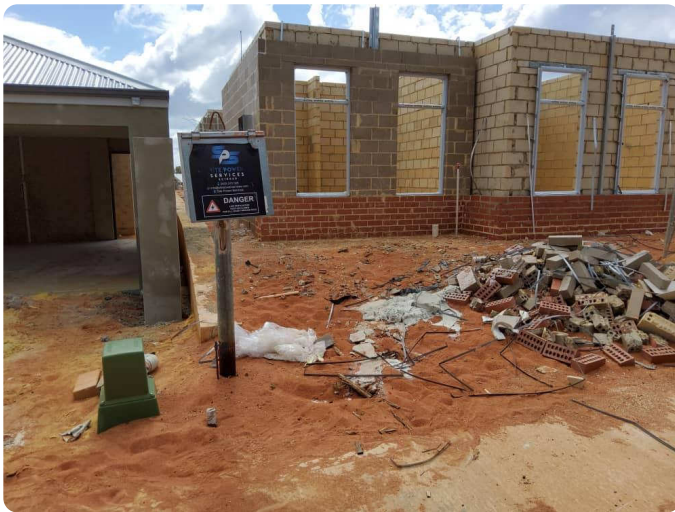
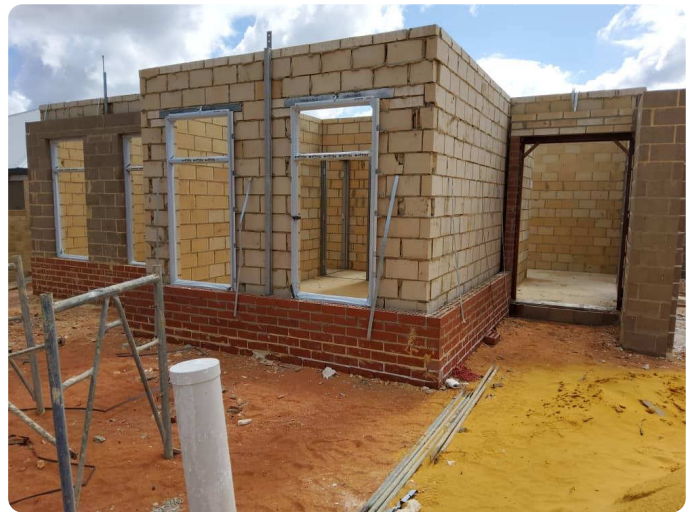
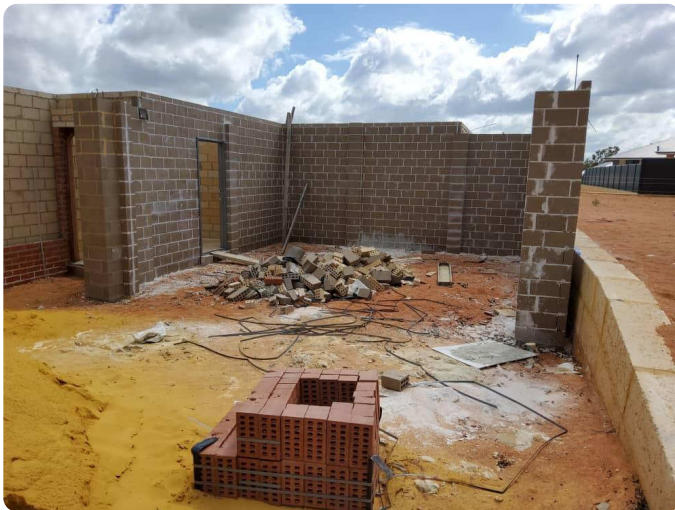
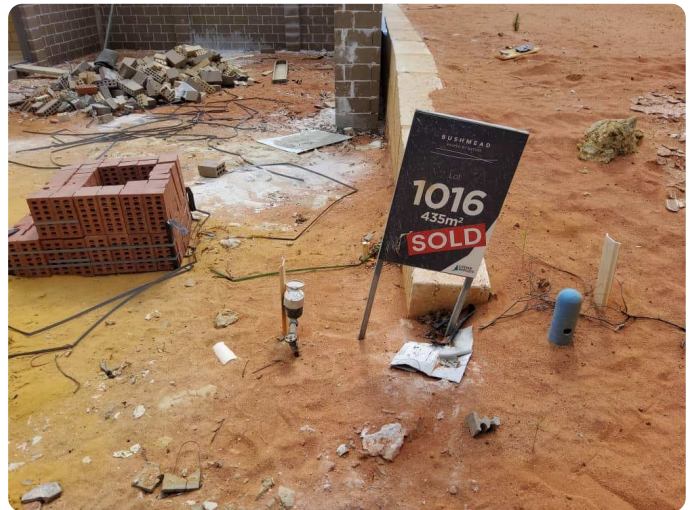
9.1 Builders sign not in situ as required

The images provided indicate there is no visible Builders sign on site. The Builder is obliged to have a builders sign as per Legislation clearly visible on site.
