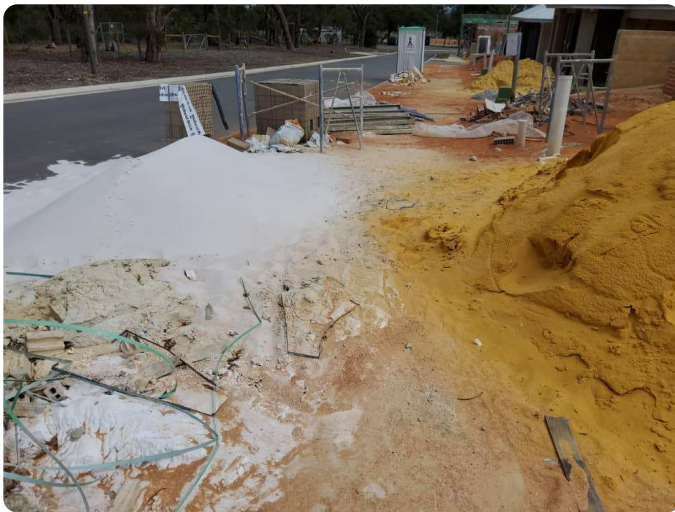
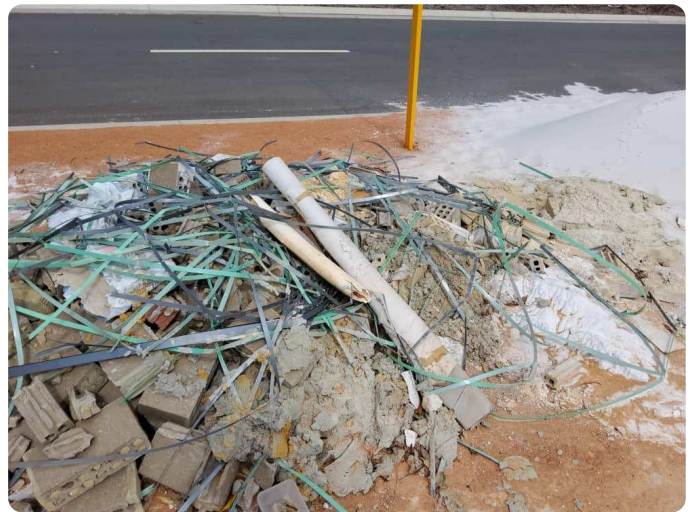
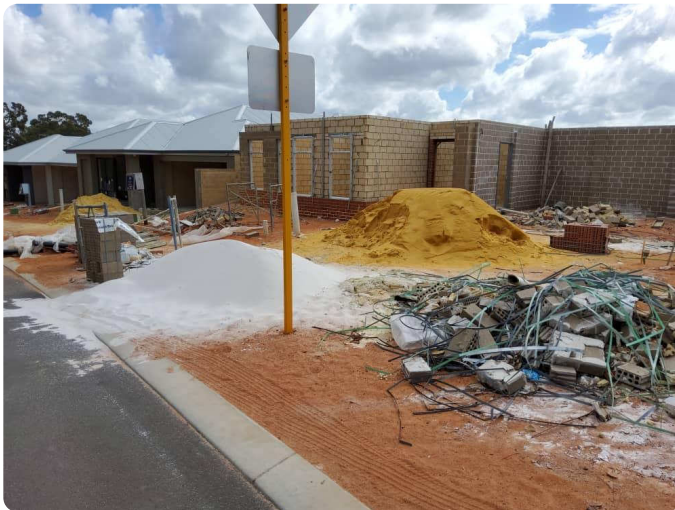
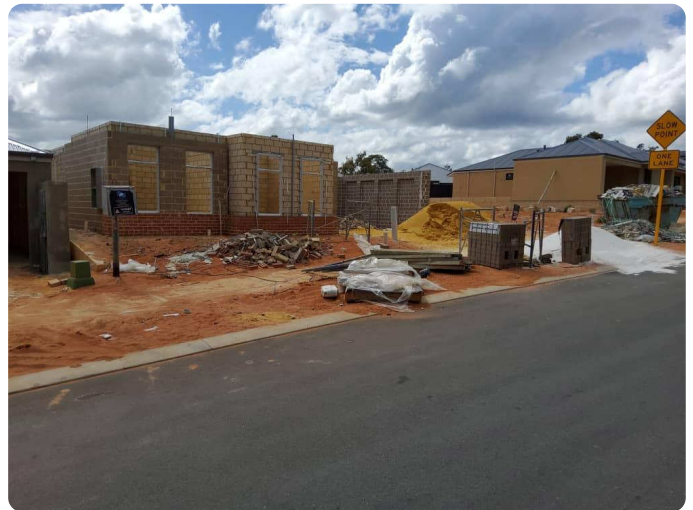
9.2 Site toilet not installed as required

The images provided indicate the site toilet is yet to be installed. This is a health and safety requirement for construction sites and should be installed as soon as possible.

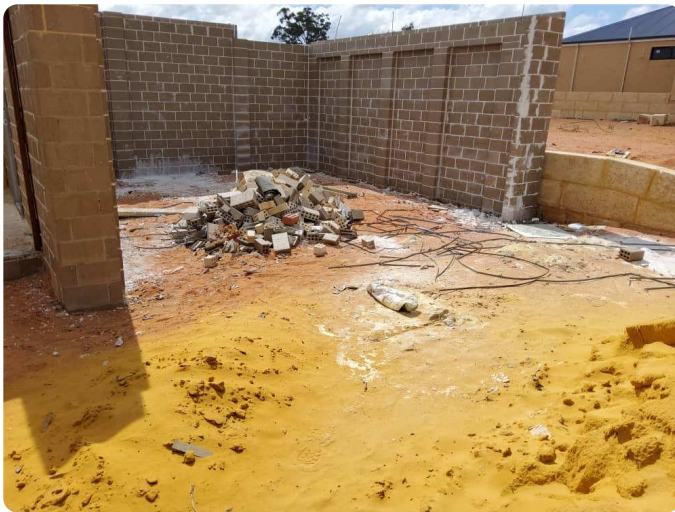
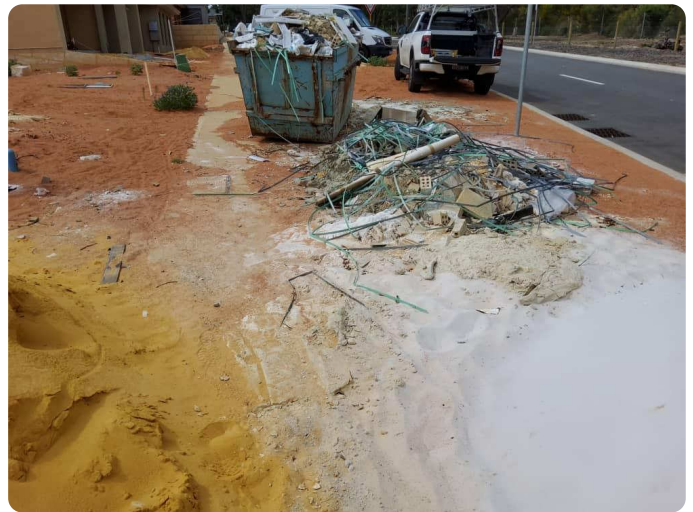
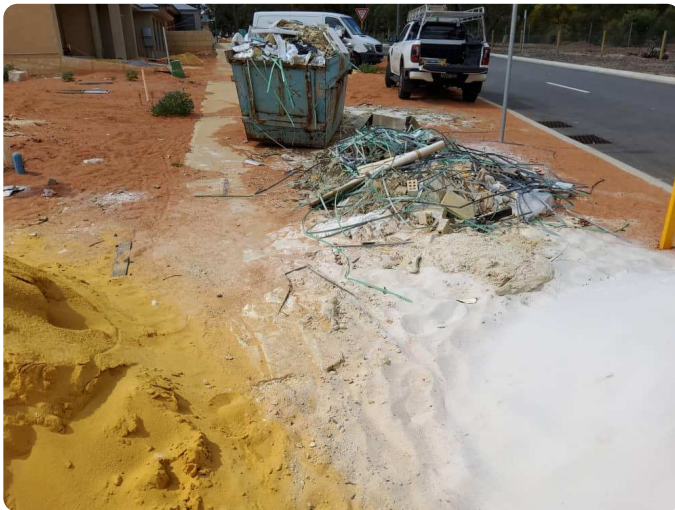
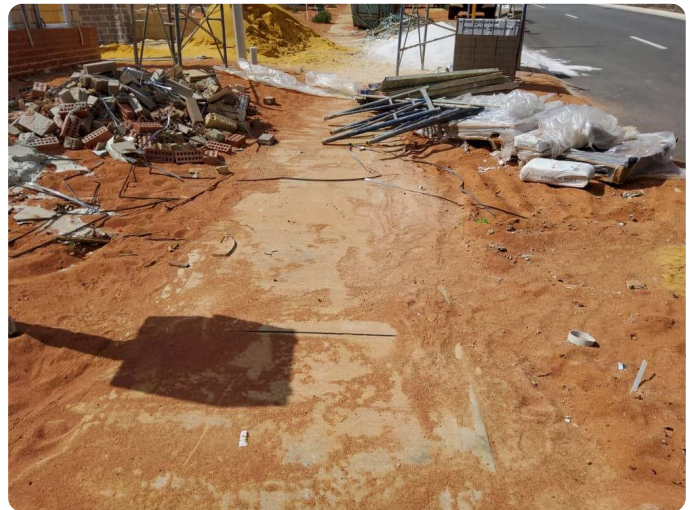
10.1 Site clean required

The images indicate the building site has excess rubbish and or builders debris. Builder should clear surplus material.

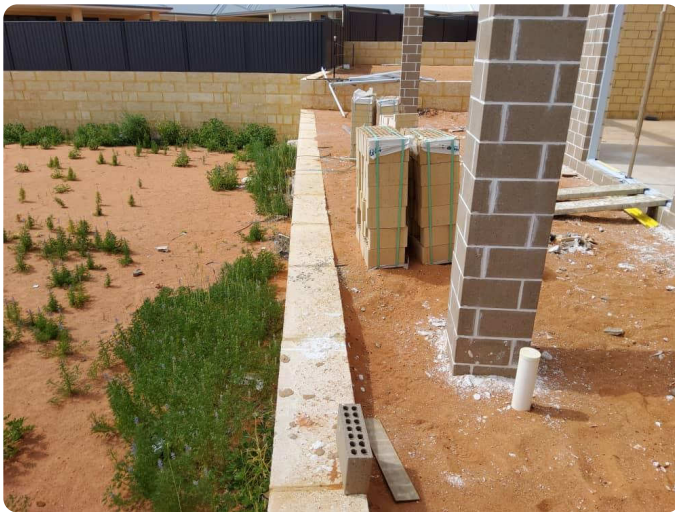
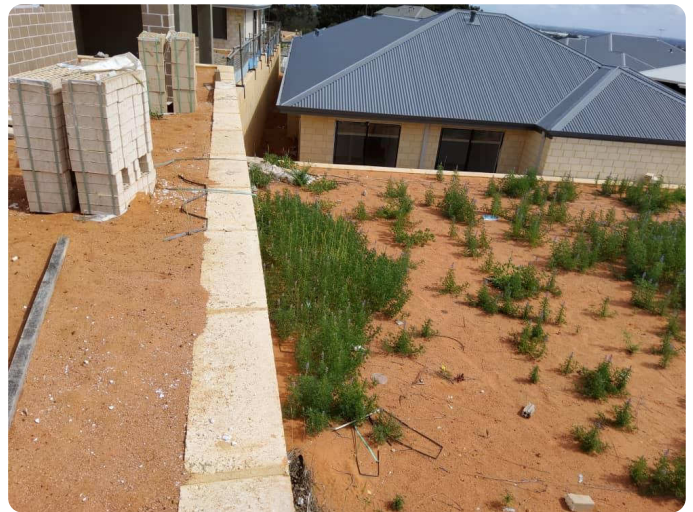
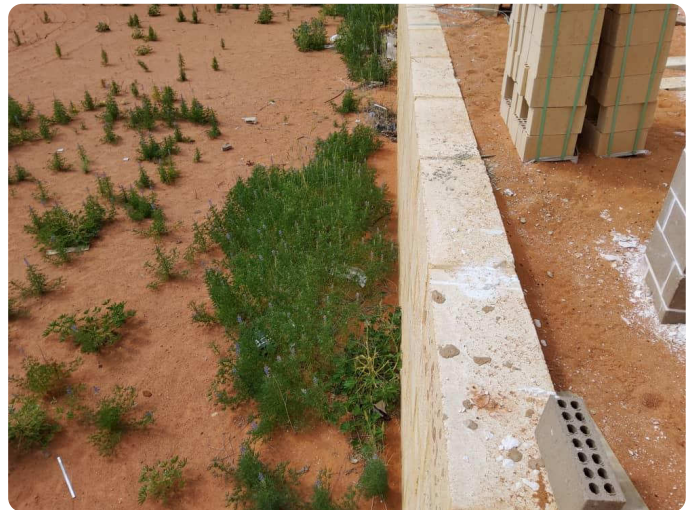
10.2 Fall protection missing from retaining wall

The images provided indicate that fall protection was not installed to retaining wall. This is a safety issue which likely breaches WA WHS obligations and requires rectification.
