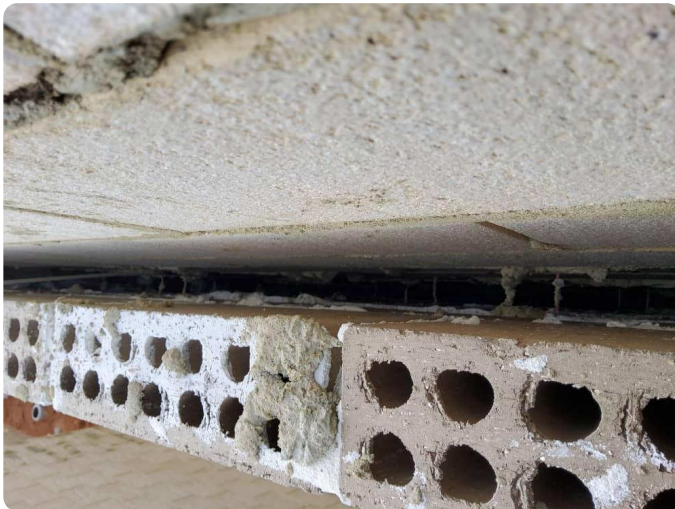
The masonry wall ties in the masonry wall shown in the image is inconsistent with the requirements of the BCA 6.1.8.1. AS 4773.2- 2015 requires that wall ties shall be placed in such a manner that they are within? (a) 300 mm of control joints; (b) 300 mm from the ends and tops of walls; (c) 300 mm from openings and intersecting walls; (d) 300 mm above intermediate floor level in two storey construction; and (e) 400 mm below intermediate floor level in two storey construction except where circumstances do not allow for this, such as where the frame is obscured by window flashing. In all cases, the maximum vertical and horizontal spacing shall not exceed 600 mm. Ties shall be doubled at intersecting walls, as shown in Figure 10.11(A). Ties shall be embedded at least 50 mm into each masonry leaf.

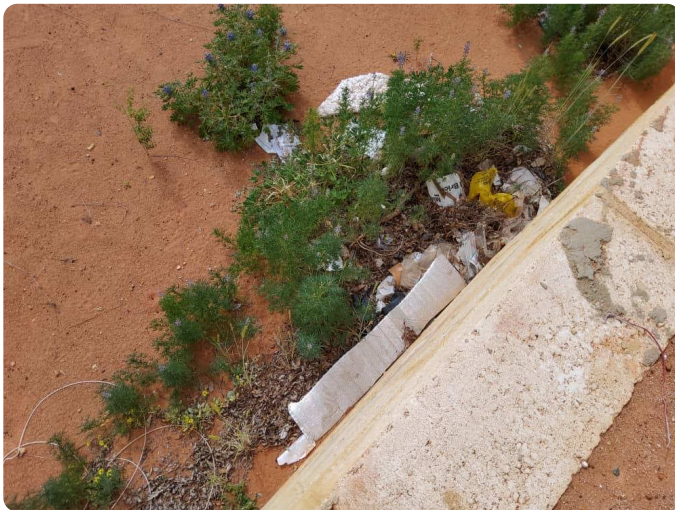
10.2 Fall protection missing from retaining wall

The images provided indicate that fall protection was not installed to retaining wall. This is a safety issue which likely breaches WA WHS obligations and requires rectification.
